INDOOR AIR QUALITY ASSESSMENT

**North Andover Police Department
566 Main Street
North Andover, Massachusetts**

Prepared by:
Massachusetts Department of Public Health
Bureau of Environmental Health Assessment
May, 2001

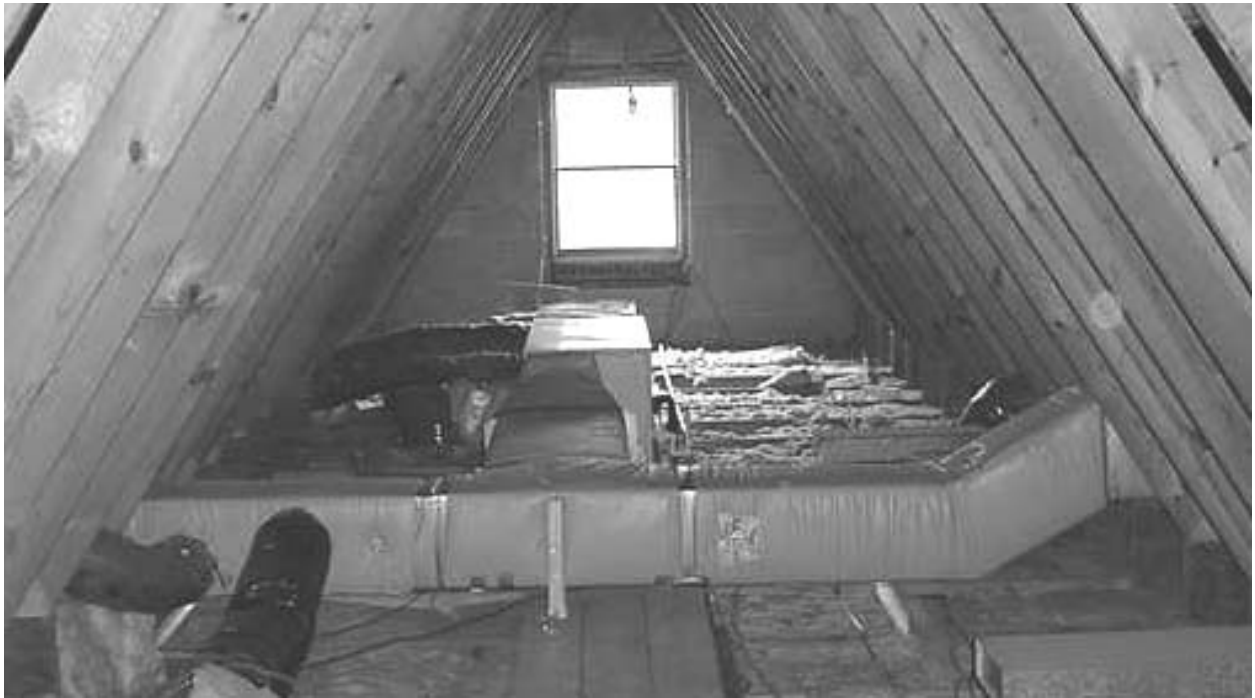
Picture 2

provides ventilation for the ground floor (see Picture 2) through ducted, ceiling vents (see Picture 3). Exhaust ventilation is provided by ceiling-mounted exhaust grilles, which return air to the AHU via ductwork (see Picture 4). The AHU has no means to introduce fresh air. In this configuration, the AHU only tempers and recirculates air within the police station. It appears that the building was originally designed to provide fresh air to interior spaces solely through openable windows.

NAPD HVAC System in Attic
Note no Provision for the Introduction of Fresh Air

1. Consider consulting a ventilation engineer concerning the introduction of fresh air. Have an HVAC engineer ascertain whether a fresh air intake and/or exhaust vent for the AHU can be installed.
2. Examine the feasibility of installing gutter/downspout system to the rear of the building.

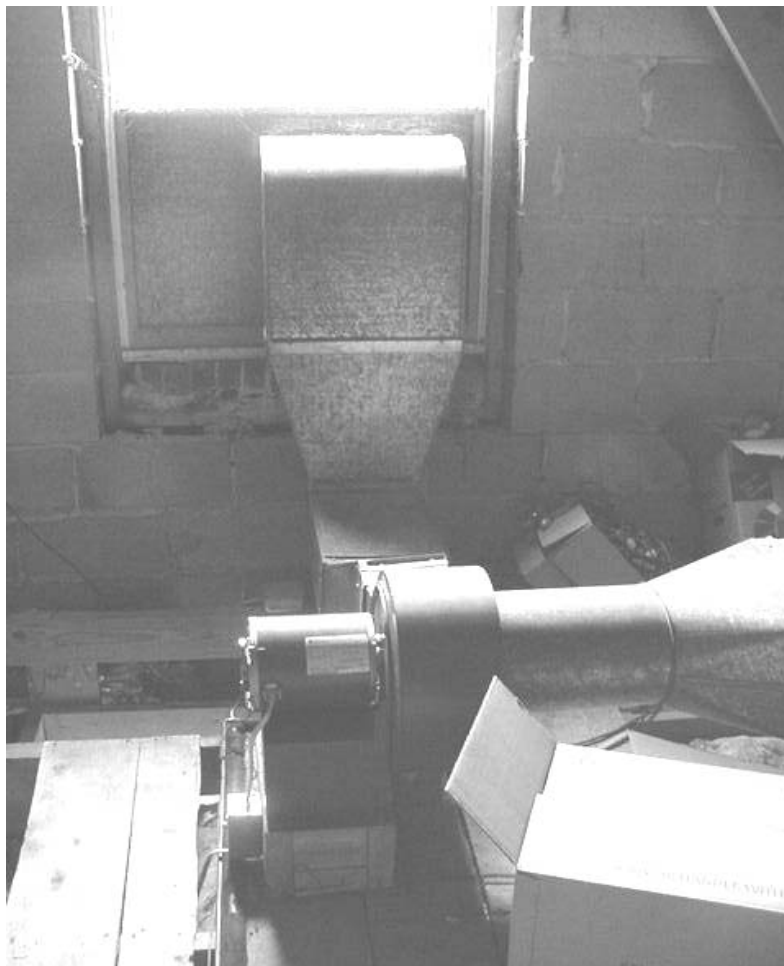
Picture 5

Exhaust ventilation is provided to the booking and prisoner cellblock areas by a mechanical system connected to an attic exhaust motor via ductwork (see Picture 5). This system was not in operation during the BEHA assessment. With the lack of fresh air supply and exhaust ventilation, pollutants that exist in the interior space cannot be diluted and will build up and remain in the indoor environment.

Exhaust Ventilation System in Attic

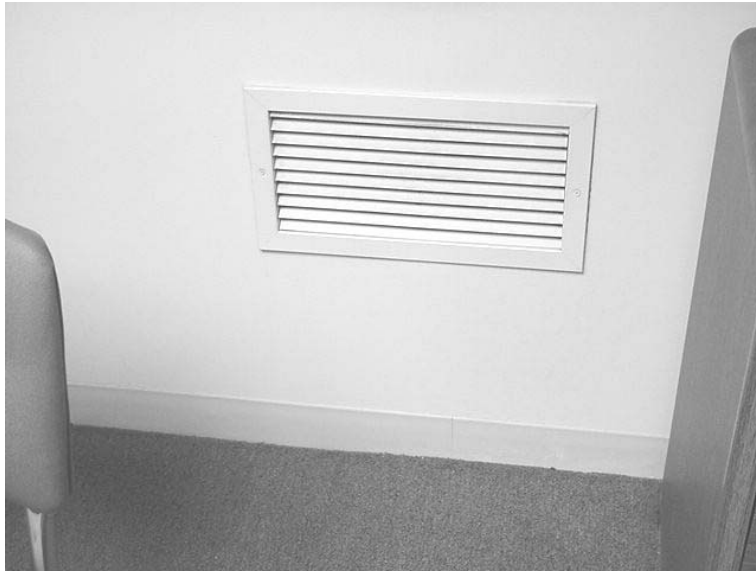
Picture 6

Ventilation for the basement storage areas and offices is provided by an AHU, which also had no provision for the introduction of fresh air. Exhaust ventilation for these areas is provided by a single wall-mounted return vent in the secretary's office (see Picture 6). Passive grills are mounted on doors (e.g., Chief's office & briefing room) to draw air into the secretary's office and out of the building through the exhaust vent located in the radio room (see Pictures 7 & 8). Carbon dioxide readings in these areas were slightly above 800 ppm, which as discussed previously can indicate inadequate air circulation. Mechanical exhaust vents in basement restrooms (including the Chief's office) were operating at the time of the assessment; however, each was drawing air very weakly and may not be sufficient to provide proper exhaust. In addition, exhaust ductwork for restroom vents must travel a great distance (across the entire length of the basement) then go through a series of 90° angles before reaching the exhaust

Wall-Mounted Return Vent in Secretary's Office (Basement)

5. Ensure basement return vents (e.g., secretary's office) are clear of obstructions to allow for proper airflow.
6. Consider having the ventilation system balanced by an HVAC engineer.

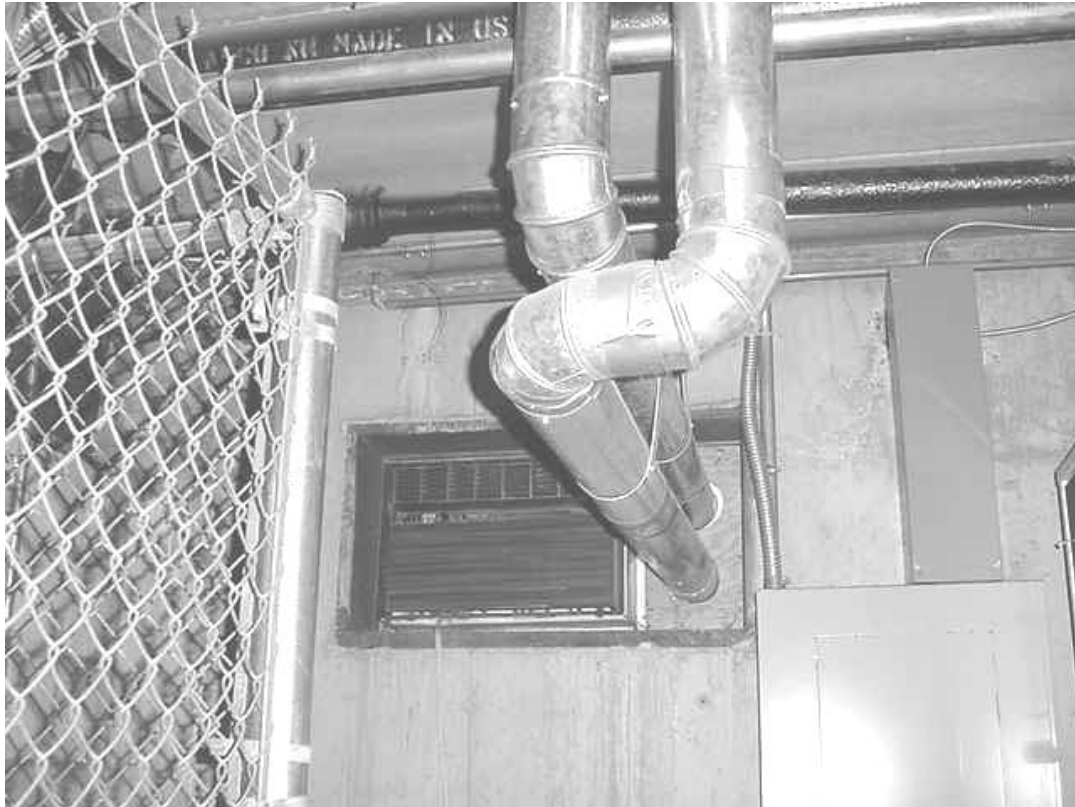
Picture 8

terminus on the exterior wall (see Picture 8). Airflow is decreased roughly in half by every 90° angle that exists in ductwork. BEHA staff observed damaged flexible ductwork above ceiling tiles in the basement restroom (see Picture 9).

Exhaust Vent Termini in Basement

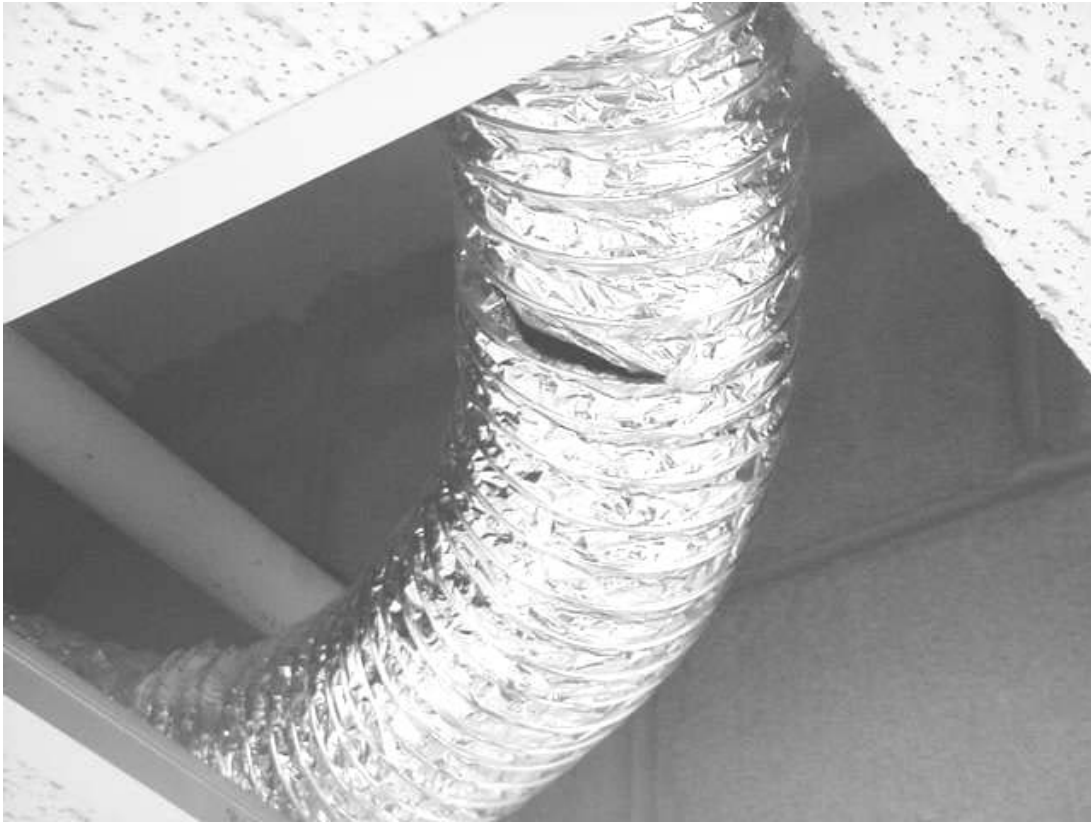
Picture 9

Damaged Flexible Ductwork above Ceiling Tiles in Restroom

4. Repair damaged flexible ductwork above ceiling tiles in the basement restroom.
Operate the rest room exhaust vents to prevent odors entering occupied areas.
Consider placing a timer to run the vent system during office hours.

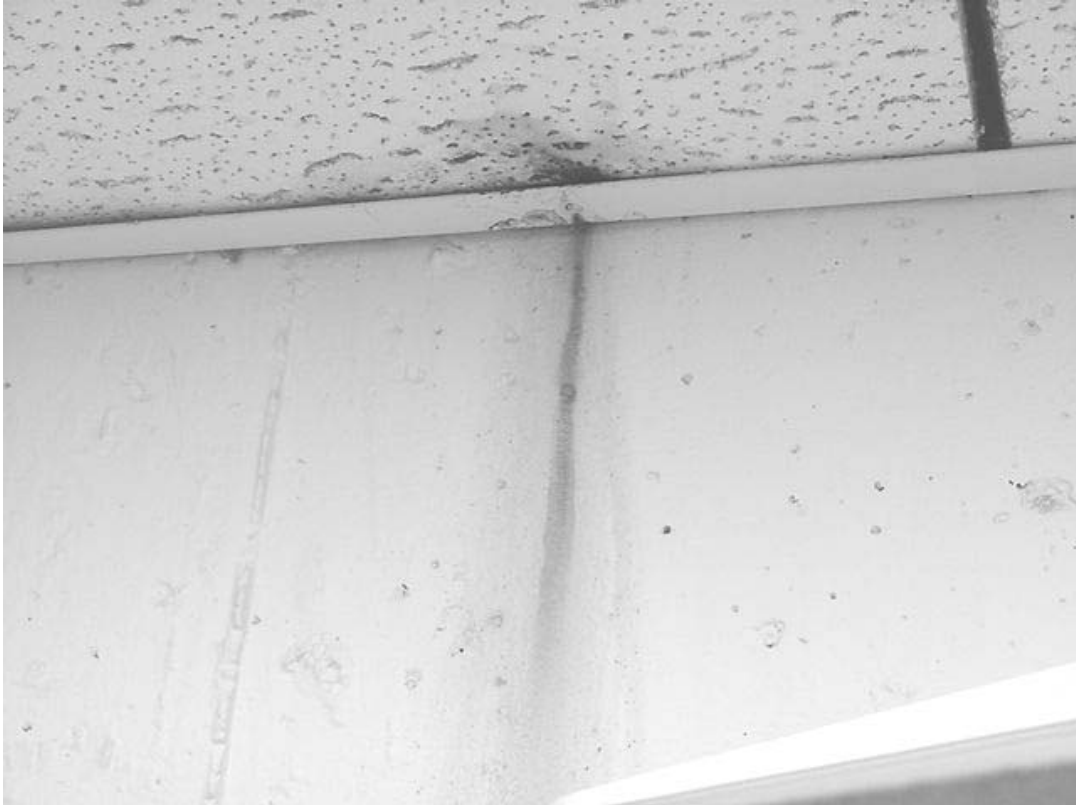
Picture 14

Water stained ceiling tiles were observed in some areas of the police station. Water-damaged ceiling tiles can provide a source of microbial growth and should be replaced after a water leak is discovered. Active leaks were reported in the support services office and in Lt. Carney's/OIC office. The basement storeroom had stained ceiling tiles, one exhibiting possible mold growth (see Picture 14). A vertical rust colored stain was seen on the wall below this area indicating an historical leak. BEHA staff examined the ceiling plenum. No current sources of moisture or active microbial growth were seen. Cardboard boxes were stored on the floor beneath the general area of the water-damaged ceiling tiles. A black substance, which may be mold, was noted on the floor beneath several of these boxes (see Picture 15). Like other porous materials, if colonized with mold they must be discarded.

**Water Damaged Ceiling Tile with Possible Mold Growth in Basement Storeroom
Note Vertical Water Stain on Wall**

9. Monitor basement storage area for leaks. Inspect cardboard boxes individually for water damage/mold growth, if moldy discard. If leakage reoccurs, store porous materials elsewhere.

12. Repair any existing water leaks and replace any remaining water-stained ceiling tiles. Examine the areas above these tiles for mold growth. Disinfect areas of water leaks with an appropriate antimicrobial as needed.

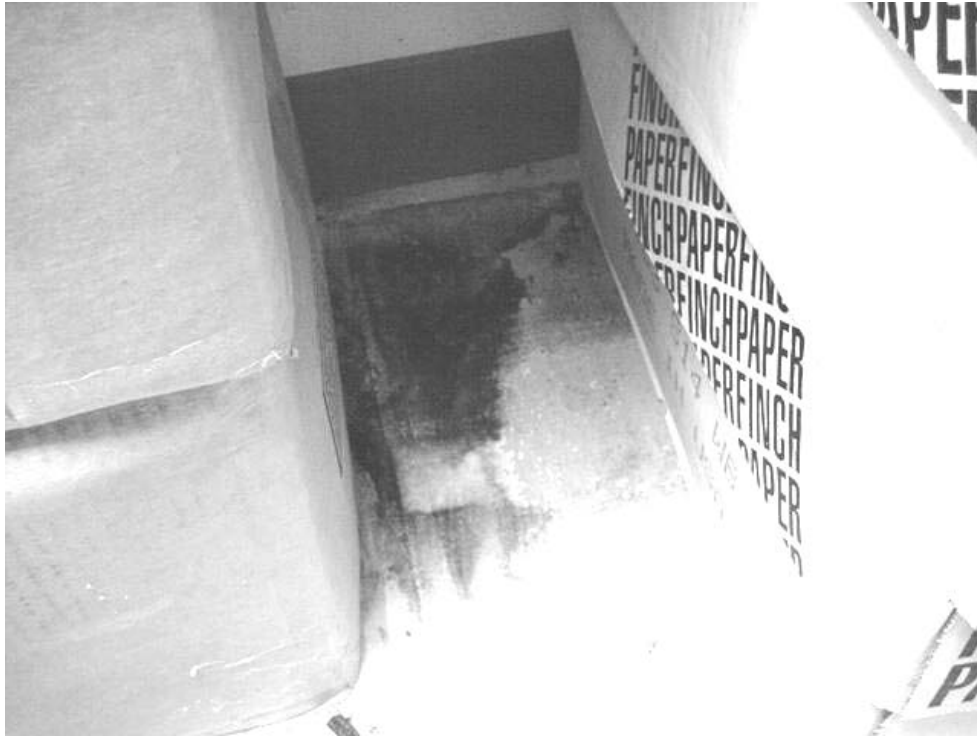
Picture 15

Black Stains on Cement Floor underneath Boxes in Basement Storeroom

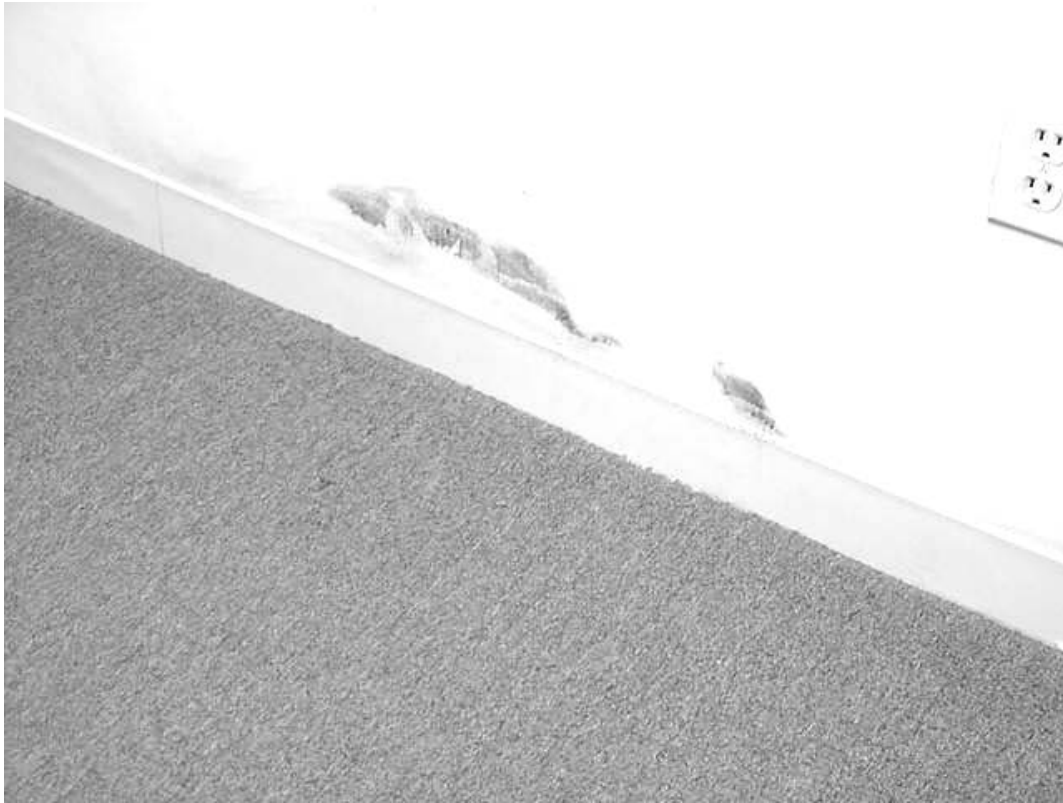
Picture 16

Active mold growth was noted on the gypsum wallboard of the storeroom in the secretary's area (see Picture 16). Building occupants reported that the area of microbial growth has been cleaned and disinfected repeatedly. No obvious sources of interior moisture problems were noted. BEHA staff observed conditions along the outside perimeter of the building adjacent to this area to identify breaches in the building envelope, which would provide a source of water penetration. The most likely sources were along the exterior wall/tarmac junction and/or a utility hole created in the concrete foundation for electrical wires (see Pictures 17 & 18). The rear of the building is not equipped with a gutter system (see Picture 1) which can allow rainwater to run down the side of the building and pool against the foundation depending on wind and weather conditions. Spaces between the tarmac and exterior walls of the building can bring moisture in and eventually lead to cracks and/or fissures in the foundation below ground level. This can breach the integrity of the building envelope and serve as a source of water penetration and subsequent water damage to building materials (e.g., gypsum wallboard).

Like other porous materials, if gypsum wallboard becomes wet repeatedly it can provide a medium for mold growth. Mold and related particulates can be irritating to sensitive individuals. Water-damaged gypsum wallboard cannot be adequately cleaned to remove mold growth. Once mold has colonized, discarding the material is advised. Removing the water-damaged gypsum wallboard will also give maintenance personnel the opportunity to observe conditions within the wall cavity and to determine characteristic signs of water penetration through breaches of the building envelope.

Black Substance Indicating Possible Mold Growth on Wallboard in Secretary's Storeroom

8. Remove/replace water damaged gypsum wallboard in secretary's storeroom. Once gypsum wallboard is removed area should be thoroughly inspected for water penetration through breaches in the building envelope. Disinfect areas of water leaks with an appropriate antimicrobial. Clean areas of antimicrobial application when dry.

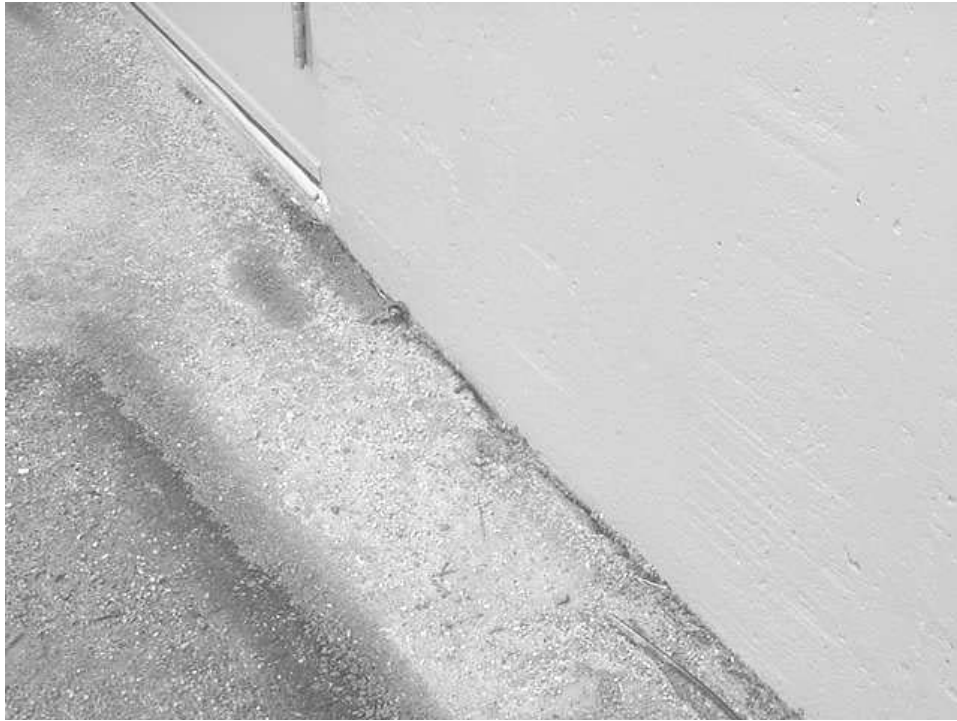
Picture 17

**Seam between the Exterior Wall/Tarmac at the Rear of the Building
(Outside of Secretary's Storeroom)**

10. Seal hole around electrical wires on exterior of building.
11. Seal cracks between the exterior wall/foundation of the building to prevent water penetration.

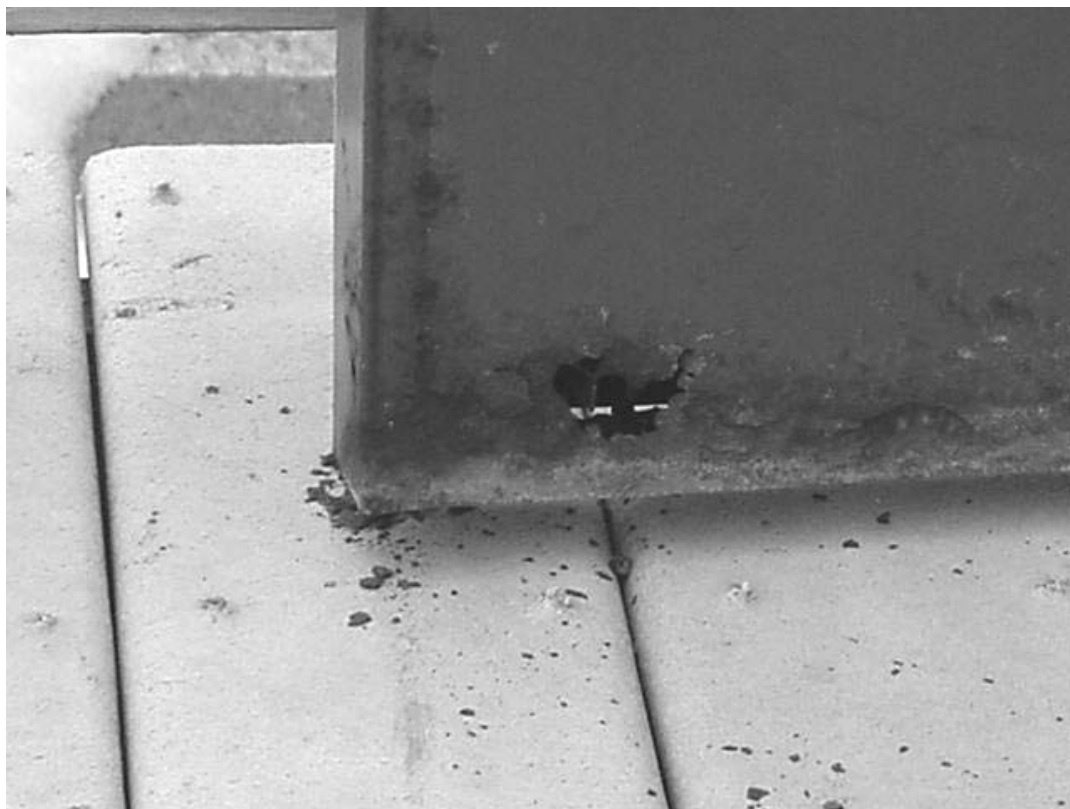
Picture 19

The exterior door of the detective unit was severely corroded by water damage (see Picture 19). Drafts were noted and light could be seen penetrating through a hole in the door.

Corroded Exterior Door of Detectives Unit

13. Replace water-damaged exterior door in the detectives unit.
14. Consider increasing the dust-spot efficiency of HVAC filters. Prior to any increase of filtration, each piece of air handling equipment should be evaluated by a ventilation engineer as to whether it can maintain function with more efficient filters.

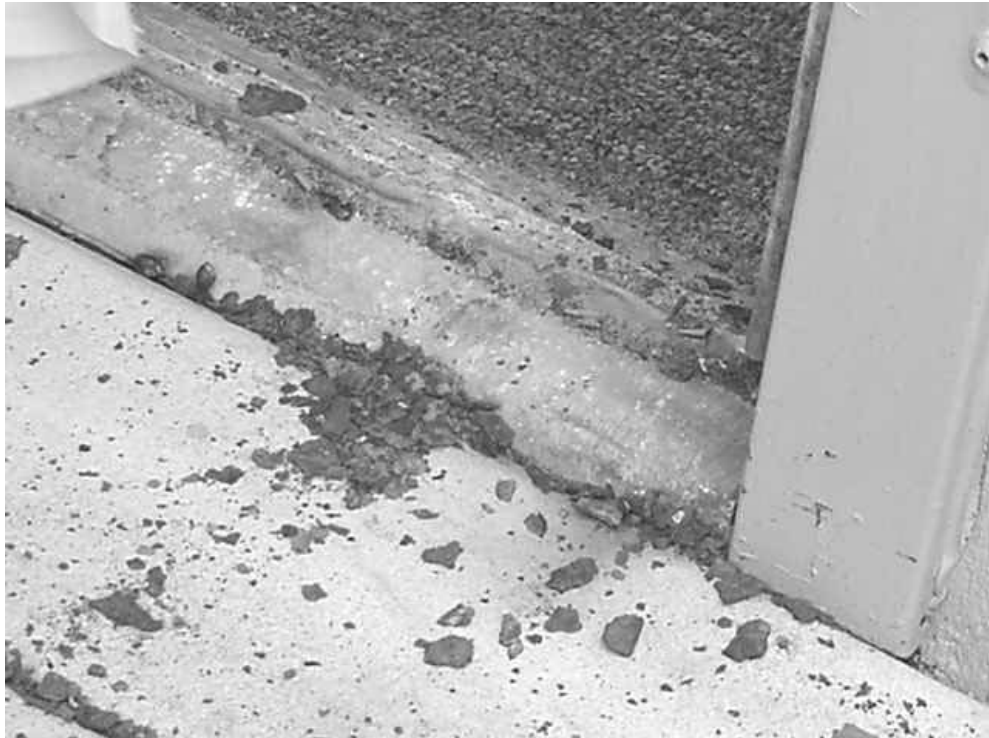
Picture 20

Rusted metal chips were also noted in the area (see Picture 20). The floor around this door is carpeted. Depending on wind and weather conditions, rainwater can penetrate through the space and wet carpeting and other porous building materials. The American Conference of Governmental Industrial Hygienists (ACGIH) recommends that carpeting be dried with fans and heating within 24 hours of becoming wet (ACGIH, 1989). If carpets are not dried within this time frame, mold growth may occur. Once mold has colonized porous materials, they are difficult to clean and should be removed.

Fragments of Corroded Metal from Detectives Unit Door Note Carpeting in Hallway

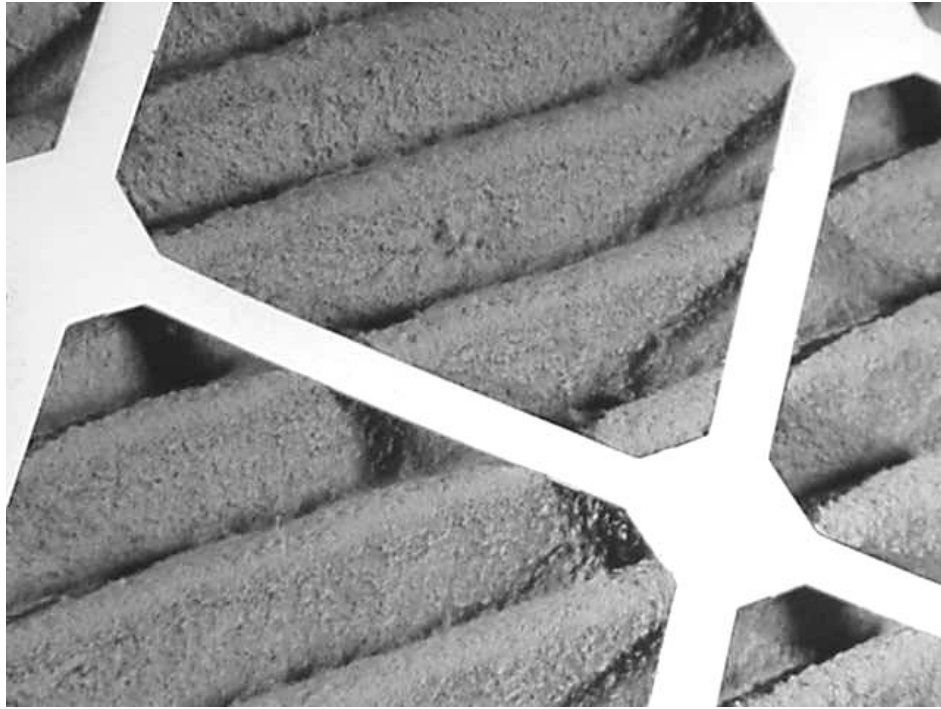
Picture 21

Several conditions that can potentially affect indoor air quality were also identified. BEHA staff examined the AHU in the attic and found the filter coated with dirt/dust and accumulated material (see Picture 21). A debris-saturated filter can obstruct airflow and may serve as a reservoir of particulates that can be re-aerosolized and distributed to occupied areas via the ventilation system. In addition, the filter access panel was not re-installed and was located approximately two-feet from the unit on the fiberglass insulation (see Picture 22). If not installed, the lack of the filter access panel will render the AHU casing non-airtight and will draw air from the attic space into the unit. As air bypasses filters, the opportunity exists for airborne dirt, dust and particulates to be distributed to occupied areas via the HVAC system. Aerosolized dust, particulates and fiberglass can provide a source of eye, skin and respiratory irritation to certain individuals. In addition, these materials can accumulate on flat surfaces (e.g., desktops, shelving, and carpets) in occupied areas and subsequently be re-aerosolized causing further irritation.

Close-Up of AHU Filter Saturated with Dirt/Dust

1. A preventative maintenance program for all HVAC equipment should be developed and implemented, which should include changing filters for AHU equipment as per the manufacturer's instructions or more frequently if needed, as well as the examination of all HVAC equipment periodically for maintenance and function.
2. After replacing filters, reinstall filter access plate and operate the ventilation system during building occupancy.
3. Consider setting thermostat controls in the detective's unit to the "on" position to provide constant supply and exhaust ventilation during periods of occupancy.

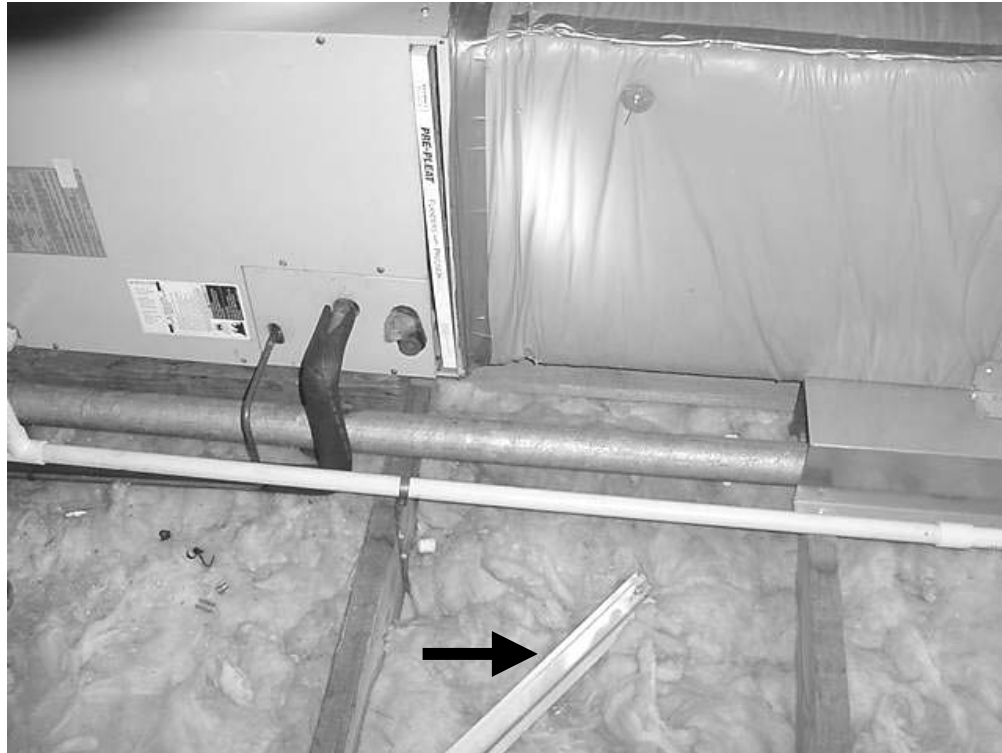
Picture 22

**AHU in Attic Note Filter Access Cover Removed (Indicated by Arrow)
and Exposed Fiberglass Insulation**

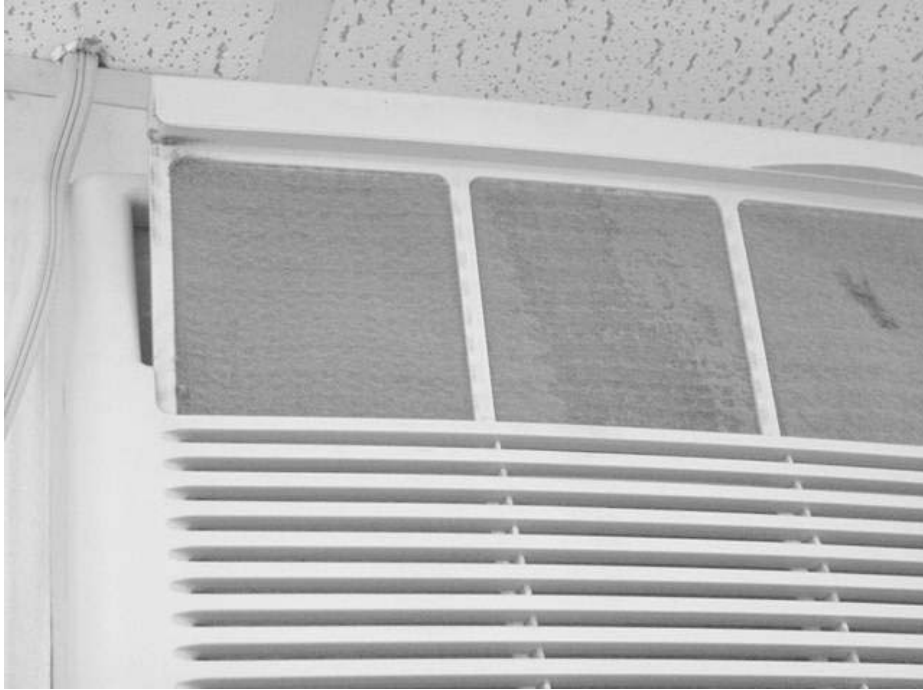
Picture 23

A portable air conditioning unit is mounted in the wall of the dispatch area. BEHA staff inspected the filter to this unit and found it coated with dirt/dust (see Picture 23). As with the AHU, the activation of the air conditioner can re-aerosolize dirt, dust and particulate, which can be irritating to certain individuals.

Wall-Mounted Air Conditioner with Dirty Filter (Pulled Out) in Dispatch Area

15. Change filters in wall-mounted air conditioners as per the manufacturer's instructions to prevent the re-aerosolization of dirt, dust and particulate matter.

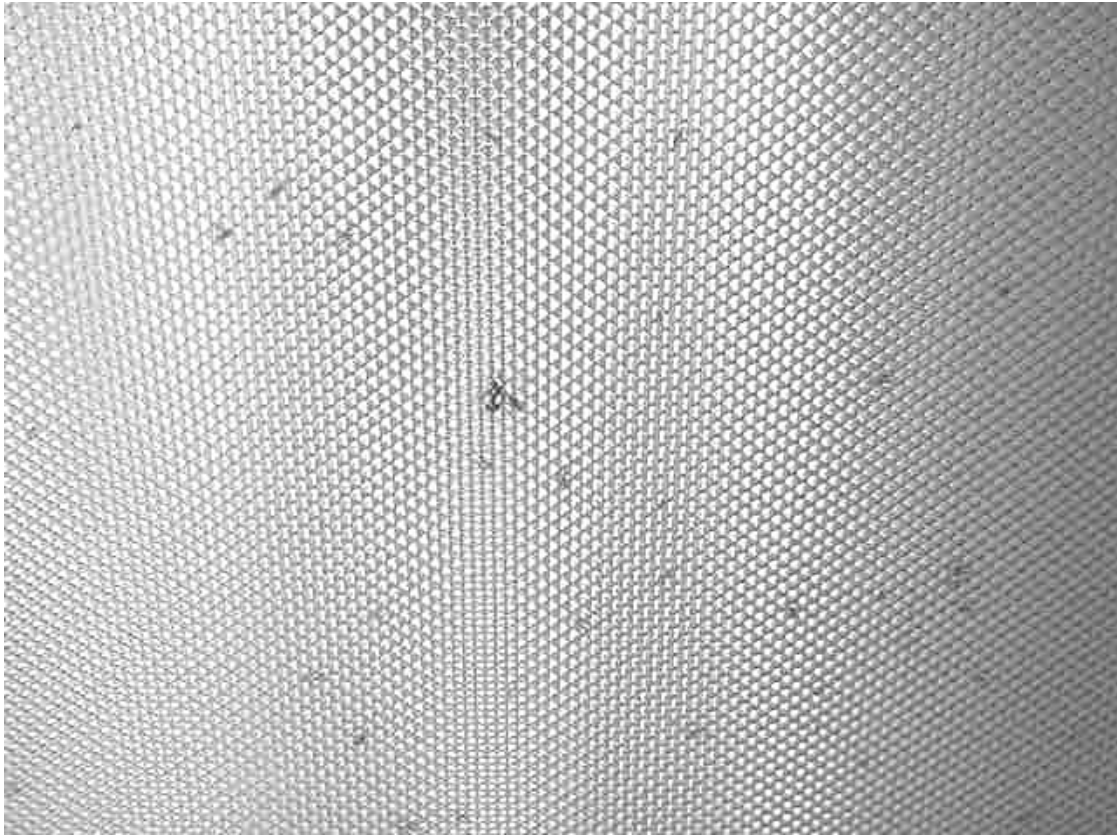
Picture 24

The building showed signs of insect infestation. A number of insect bodies were noted above lighting fixtures (see Picture 24). Insect parts can become dried out and aerosolized and may serve as a source of allergenic material for sensitive individuals. The most likely route for insect penetration into the building is through spaces around attic windows. BEHA staff noted a large number of dead insects on and around attic windows. Once inside the attic, insects attracted to light appear to have entered light fixtures through small openings in the fixtures where they became trapped. Under current Massachusetts law that will go into effect November 1, 2001, the principles of integrated pest management (IPM) must be used to remove pests in state buildings (Mass Act, 2000). Although the NAPD is not a state building, the principles of IPM are recommended as a safer alternative to the application of pesticides. A copy of the IPM guide is attached as [Appendix A](#). Pesticide use indoors can introduce chemicals into the indoor environment that can be a source of eye, nose and throat irritation. The reduction/elimination of pathways of egress into the building should be the first step taken to eliminate this infestation.

Close-Up of Ceiling Mounted Light Fixture Dark Spots Indicate Insect Bodies

16. Use IPM to remove pests from the building. A copy of the IPM recommendations is included with this report as Appendix A (MDFA, 1996). Activities that can be used to eliminate pest infestation may include the following activities.

- i) Consult a licensed pesticide applicator on the most appropriate method to end infestation.
 - ii) Reduction/elimination of pathways/food sources that are attracting pests.

- iii) Reduce harborages (plants/cardboard boxes) where pests may reside.
